Pentium[®] Processor Specification Update

Release Date: June, 1997

Order Number 242480-028

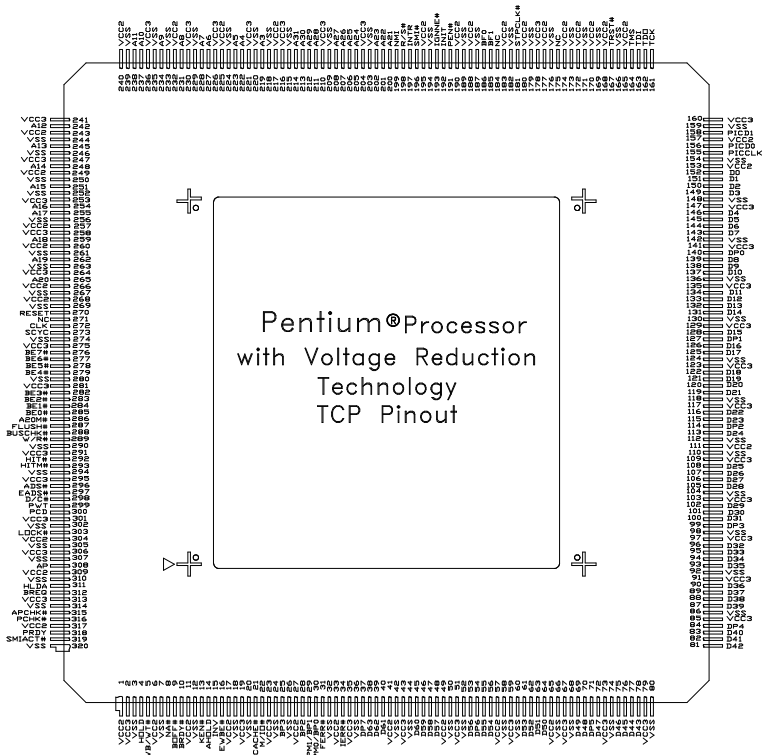
2. **Incorrect TCP Pinout Drawing**

The TCP pinout drawing on page 8 of the *Pentium Processor with Voltage Reduction Technology* datasheet was inadvertently rotated. The correct orientation is shown below.

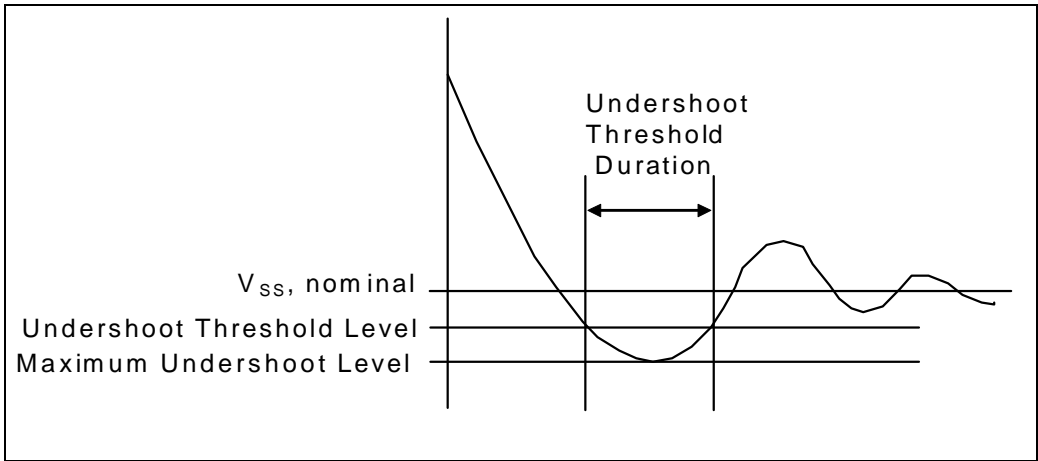
Figure 14-1. Maximum Undershoot Level, Undershoot Threshold Level, and Undershoot Threshold Duration

UNDERSHOOT THRESHOLD DURATION SPECIFICATION: A snapshot of the clock signal should be taken at 500 mV/div and 500 pS/div (for CLK). Adjust the vertical position and horizontal offset position to view the threshold duration. The undershoot threshold duration is defined as the sum of all time during which the clock signal is below -0.5V within a single clock period. The undershoot threshold duration must not exceed 20% of the period.

This undershoot specifications are illustrated graphically in Figure 14-1 and Figure 14-2.

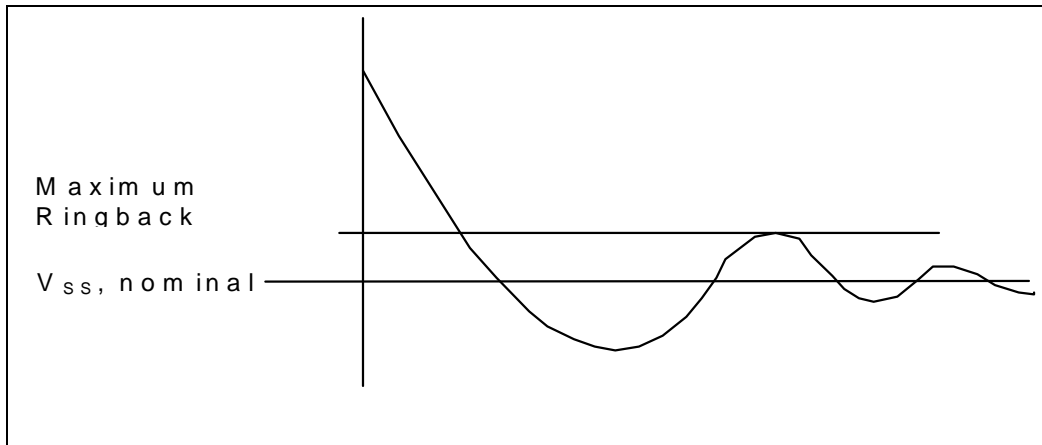
Figure 14-2. Maximum Ringback Associated with the Signal Low State

MAXIMUM UNDERSHOOT AND MAXIMUM RINGBACK SPECIFICATIONS: The display should show continuous sampling (e.g., infinite persistence) of the waveform at 500 mV/div and 5 ns/div (for CLK) for a recommended duration of approximately five seconds. Adjust the vertical position to measure the maximum undershoot and associated ringback. There is no allowance for crossing the maximum undershoot or maximum ringback specifications.
