Intel® 450NX PCIset Specification Update

Release Date: April 1999

Order Number: 243848-009

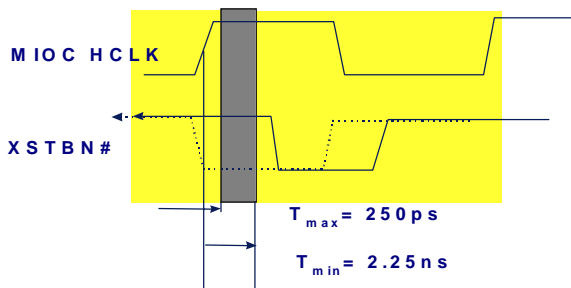
Figure 2. Timing Window Where Strobe Falling Edge Must Be Avoided

IMPLICATIONS: An Expander (F16) Bus error, when detected, will cause an F16 Bus Parity Error to be flagged in the MIOC's ERRSTS register and displayed on the ERR#[1:0] monitor pins. While no data corruption would result, the erroneous parity check and resulting failure may result in a BINIT# assertion by the chipset when BINIT# assertion is enabled.

WORKAROUND: The failure band is narrow enough that slightly varying XSTBN# falling-edge arrival with respect to MIOC's data-output timing can prevent the failure from occurring. Delaying XnCLK from the MIOC to the PXB can vary this timing and can be accomplished by adding extra loading or trace-routing to the XnCLK signal routing (if adjusting the entire F16-bus routing is not feasible due to existing board layout). To assist in designing board layout for avoidance of this problem, consider calculating the sum of the following system timing parameters and comparing against the limits of the failure band or timing "window."

Implementing this workaround may require deviating from the clock-skew specification. The skew between XpClkFB at the MIOC and XpCLK at the PXB may need to increase to account for a delay to the XpCLK line. Note that due to min/ max parameter variances, it may not be possible to design a workaround which can guarantee avoidance of the failing timing scenario, at least not without violating other timings. If this is the case, calculating the above timing and comparing min/ typ/ max values may still provide some assistance in designing a system workaround which could minimize exposure to this problem.
