Intel® 82371AB (PIIX4)

Specification Update

April 1999

Order Number: 297738-011

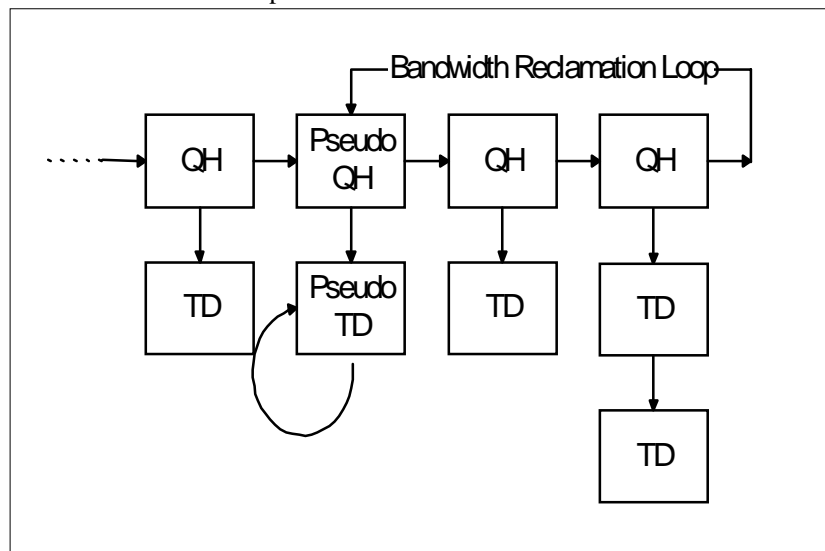
Problem: This errata affects data transfers in conjunction with a UHCI driver utilizing bandwidth reclamation. In a data structure which implements bandwidth reclamation, when all the queue heads have their terminate bit set (empty QH's), the USB subsystem will be unable to read a new frame pointer and will continuously loop through the bandwidth reclamation queue heads. The effect of the errata is that the USB subsystem will continue to send out Start Of Frame packets but transfer no data. On the PCI bus the PIIX4 will continuously read the queue heads within the bandwidth reclamation loop. For additional information on PIIX4 host controller operation refer to the Universal Host Controller Interface (UHCI) Design Guide (order number 297650).

Implication: The USB host controller stops transferring data on the USB bus. The non-USB functions in the system will continue to operate normally.

Workaround: When using bandwidth reclamation, the UHCI driver should insert a pseudo queue head with a pseudo transfer descriptor within the bandwidth reclamation loop. The PIIX4 will fetch this queue head and transfer descriptor on every frame, but will not transfer any data and will never be terminated. The following bits must be properly set to implement the workaround:
