8XC251Sx (8XC251SA, SB, SP, SQ) SPECIFICATION UPDATE

Release Date: December, 1998

Order Number: 272836-007

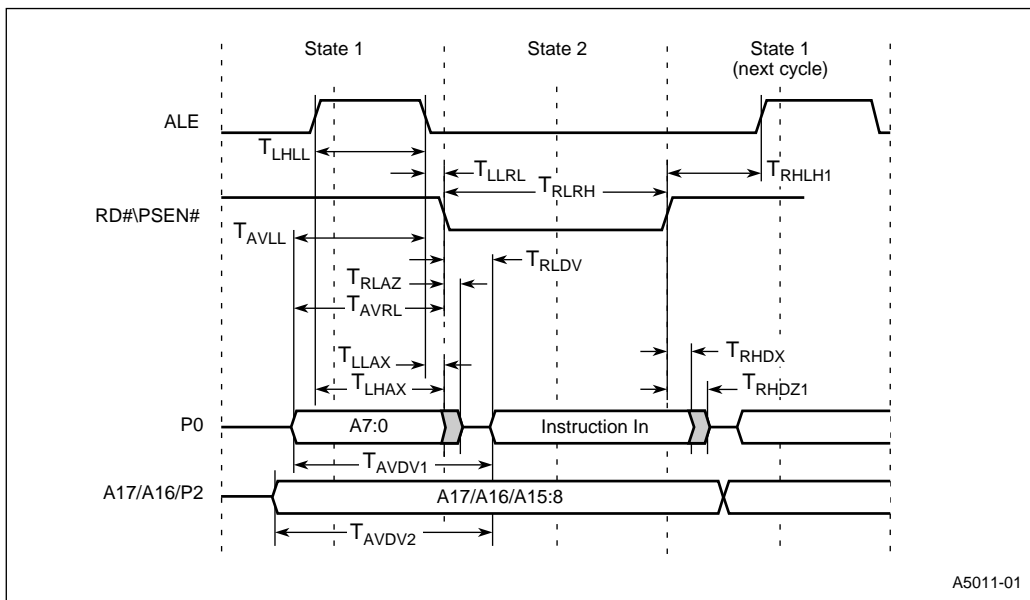
Figure 1. External Code Fetch, Nonpage Mode

PROBLEM: The TRHDZ1 (Instruction Float After RD#/PSEN# High) specification on the 8XC251Sx when operating at 12 MHz is 10 ns. However, a slow memory device such as an EPROM typically takes approximately 30 – 90 ns to float its output. (This specification generically called TPHZ, may vary from one manufacturer to another.) and illustrate the TRHDZ1 timing.

The difference between the TRHDZ1 and TPHZ specifications causes contention on the data bus (P0 in nonpage page, P2 in page mode). The 8XC251Sx begins to drive the address for the next bus cycle while the memory device is still driving data from the previous bus cycle.

To prevent this contention, designers can use a buffer to isolate the output of the memory device from the data bus (port 0 or port 2) of the 8XC251Sx. This will prevent the slow memory device from driving the data bus during the critical period after TRHDZ1 expires. We suggest a buffer such as the 74F541 octal, three-state line driver shown in Figure 3.
