# **8XC51SL**

## **SPECIFICATION UPDATE**

Release Date: July 1996

Order Number: 272877-001

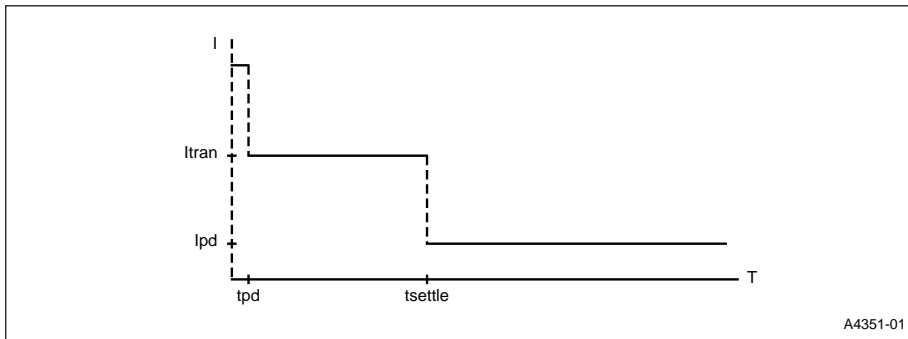
**PROBLEM:** Power down current ( $I_{pd}$ ) transitions from  $I_{cc}$  typical to the low mA range before settling into the low  $\mu A$  range.  $I_{pd}$  is also higher than estimated in the product preview data sheet. The 80C51SL-BG must also have power applied at least one minute prior to entering power down mode.

**WORKAROUND:** No work around currently available. Limited characterization data was taken (three different lots, three units per lot) to estimate  $I_{pd}$ . The following data is not guaranteed, but should be characteristic of  $I_{pd}$ .

Symbol	Parameter	Typical (25°C)	Typical (0°C)
Itran	Transition current between Icc typical and Ipd	2 mA	3 mA
Ipd	Power down current	50 $\mu$ A	800 $\mu$ A
tsettle - tpd	Time for current to transition from Icc to Ipd	80 seconds	18 minutes

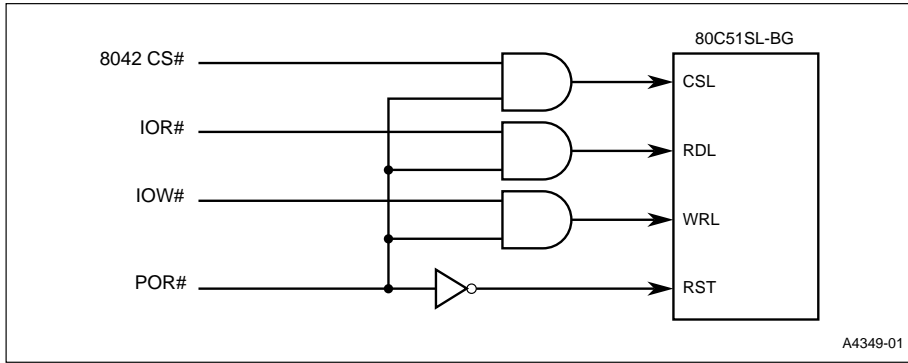
**PROBLEM:** Intel has confirmed that there is an intermittent reset problem with the 8XC51SL-BG. Abnormal ALE, PSEN, and Address have been observed after reset, and in some systems several of the Port 3 pins have toggled during reset.

**IMPLICATION :** During any of the 8XC51SL-BG resets listed, a floating node within the 8XC51SL-BG may cause internal clock signals to be killed thus not allowing a valid reset.

**WORKAROUND:** Workaround #1 (external logic: 3 gates). This is Intel's recommended workaround.

Drive the 8XC51SL-BG CSL, RDL, and WRL pins low during RST to guarantee a valid RST reset (typically used for power-on reset [POR]). Driving these 8XC51SL-BG pins low during reset drives the floating node to a proper state which allows reset to occur. During the time CSL, RDL, and WRL are driven low, LED0, LED2, and PCOB0-7 will be driven low from the 8XC51SL-BG.

Driving CSL, RDL, and WRL low during RST ensures that a valid RST reset (POR) occurs. It is possible for the problem node to float during non-RST resets after it has been initially set during a RST reset with the workaround in place. If this occurs the system user will have to issue one or more additional resets if the first non-RST reset fails. However, bench test experimentation has shown no reset failures after a valid PD was applied to RST with the workaround in place. The tests were conducted at room, hot, and cold temperatures for over 8 hours with several million software resets issued. Your system should be verified to confirm that no quality issue exists on the non-RST resets after implementing this workaround. The following figure shows a typical implementation of this work around.

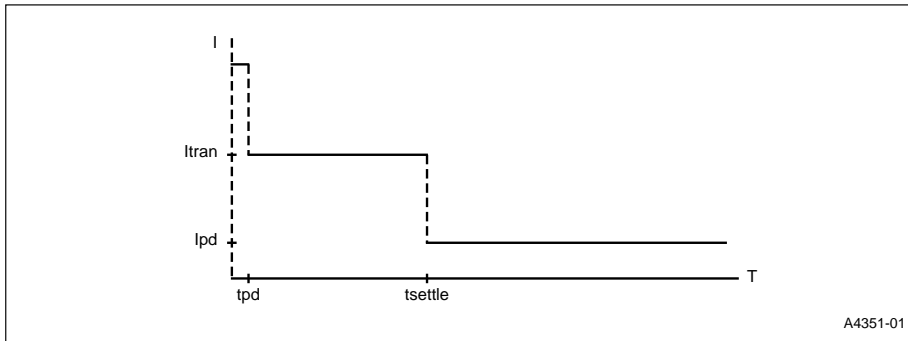
**PROBLEM:** Power down current ( $I_{pd}$ ) transitions from  $I_{cc}$  typical to the low mA range before settling into the low micro-amp range.  $I_{pd}$  is also higher than estimated in the product preview data sheet. The 80C51SL-AH/AL must have power applied at least 1 minute prior to entering power down mode.

**WORKAROUND:** No work around currently available. Limited characterization data was taken (three different lots, three units per lot) to estimate  $I_{pd}$ . The following data is not guaranteed, but should be characteristic of  $I_{pd}$ .

SYMBOL	PARAMETER	TYP (25°C)	TYP (0°C)
$I_{tran}$	Transition current between $I_{cc}$ typical and $I_{pd}$	0.6 mA (5V) 0.175 mA (3V)	0.6 mA (5V) 0.175 mA (3V)
$I_{pd}$	Power down current	200 $\mu$ A (5V) 50 $\mu$ A (5V)	200 $\mu$ A (3V) 50 $\mu$ A (5V)
$t_{settle} - t_{pd}$	Time for current to transition from $I_{cc}$ typical to $I_{pd}$	6 minutes (5V) 6 minutes (3V)	45 minutes (5V) 45 minutes (3V)
