8XC51RX

SPECIFICATION UPDATE

Release Date: July, 1996

Order Number: 272885-001

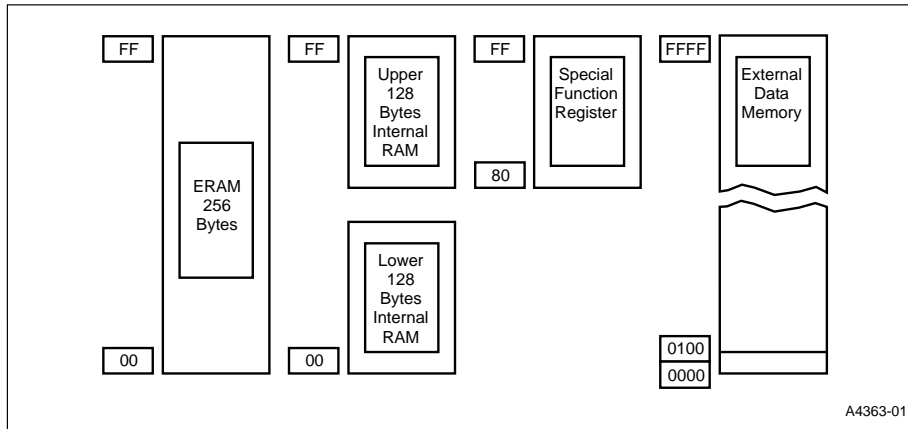
Figure 1. Internal and External Data Memory Address Space with EXTRAM = 0

PROBLEM: The default value of EXTRAM bit is 0. To use external memory, customers will need to set the EXTRAM bit to 1.

Figure 1 contains the internal and external memory address space with EXTRAM = 0. This condition accesses the 256 bytes of extended RAM and disables external memory access.
